Manhole Inspection Summary

Manhole # S45II_063MH

Insp Date: **6/19/08 10:29 AM**

Location Address: **Gay**

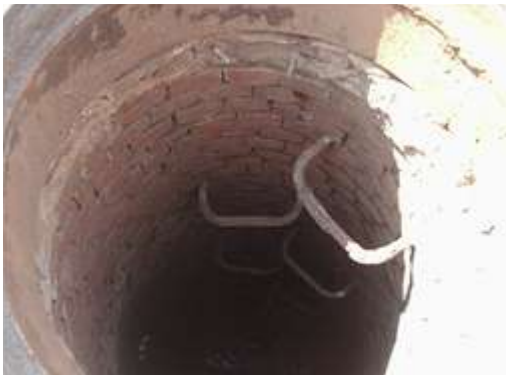
Defect 2

Condition: ☐ Sound ☐ Cracked ☐ Root Intrusion ☒ **Loose Brick** ☐ Deteriorated

Loose bricks

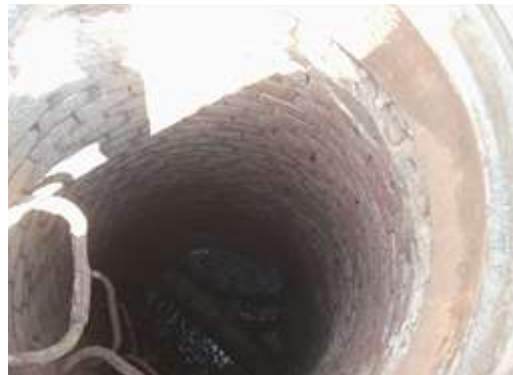
Defect 1

Infiltration: ☐ None ☒ **Joint** ☐ Cracks ☒ **Mortar** ☐ Roots ☐ Wall

Adjustment Joint

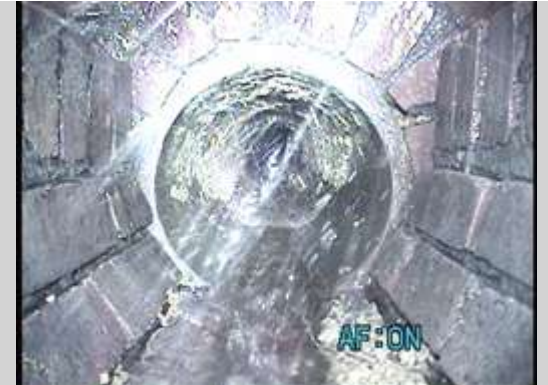
12 O'Clock Outflow

Pipe Height: **10.8** (in.) Rod and Bar (Angled)
Pipe Material: **Clay** ☐ Pipe Lined
Invert Depth: **16.95** (ft.) Flow Characteristics: **Fast**
Deposits: ☒ None ☐ Mud ☐ Sludge ☐ Debris ☐ Grease
Silt Depth: (in.) Deposits Extent:
Infiltration: **None** Pipe Seal Cond: **Sound**

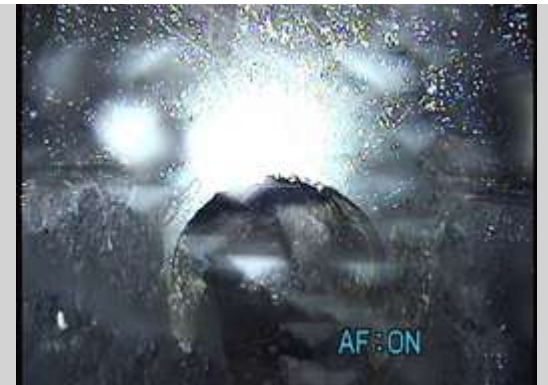
5 O'Clock Inflow

Pipe Height: **10.8** (in.) Rod and Bar (Angled)
Pipe Material: **Clay** ☐ Pipe Lined
Invert Depth: **16.90** (ft.) Flow Characteristics: **Fast**
Deposits: ☒ None ☐ Mud ☐ Sludge ☐ Debris ☐ Grease
Silt Depth: (in.) Deposits Extent:
Infiltration: **None** Pipe Seal Cond: **Sound**

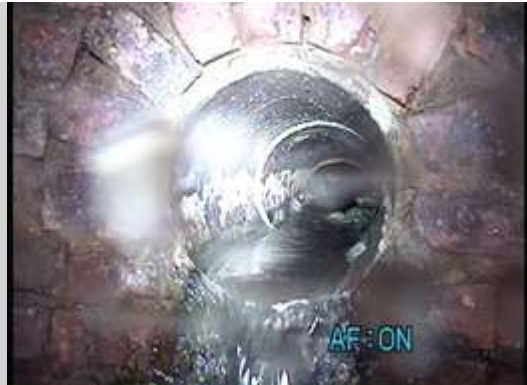
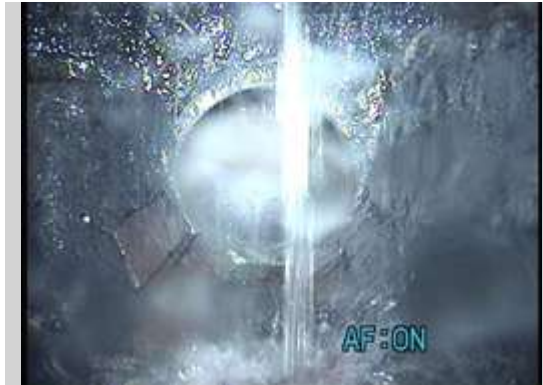
6 O'Clock Inflow

Infiltration: **None** Pipe Seal Cond: **Sound**

Drop Condition: **Open**

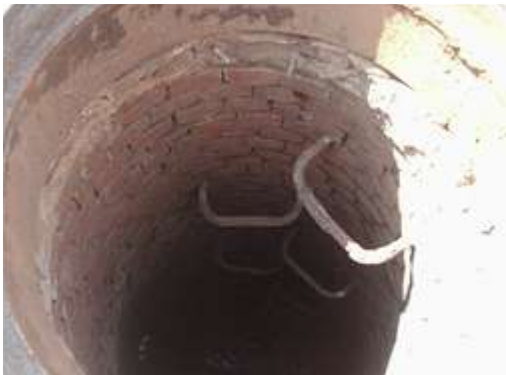
Defect 2

Condition: ☐ Sound ☐ Cracked ☐ Root Intrusion ☒ **Loose Brick** ☐ Deteriorated

Loose bricks

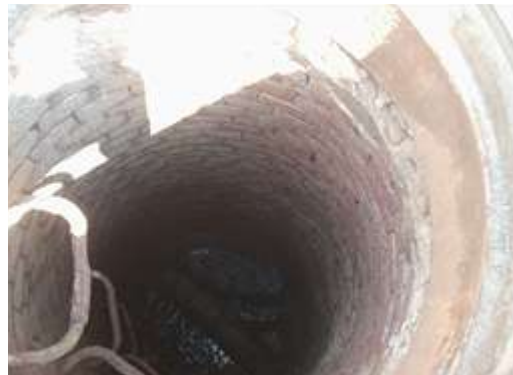
Defect 1

Infiltration: ☐ None ☒ **Joint** ☐ Cracks ☒ **Mortar** ☐ Roots ☐ Wall

Adjustment Joint

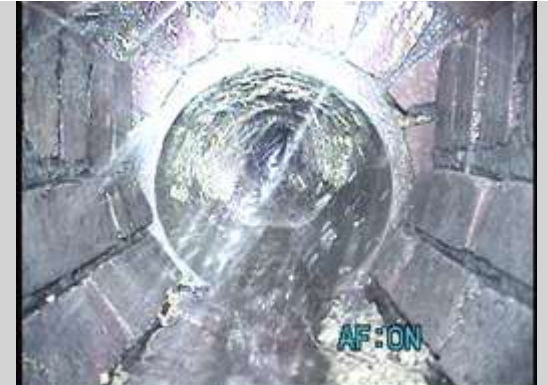
12 O'Clock Outflow

Pipe Height: **10.8** (in.) Rod and Bar (Angled)
Pipe Material: **Clay** ☐ Pipe Lined
Invert Depth: **16.95** (ft.) Flow Characteristics: **Fast**
Deposits: ☒ None ☐ Mud ☐ Sludge ☐ Debris ☐ Grease
Silt Depth: (in.) Deposits Extent:
Infiltration: **None** Pipe Seal Cond: **Sound**

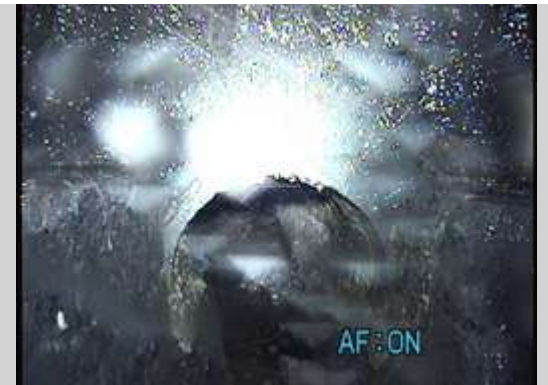
5 O'Clock Inflow

Pipe Height: **10.8** (in.) Rod and Bar (Angled)
Pipe Material: **Clay** ☐ Pipe Lined
Invert Depth: **16.90** (ft.) Flow Characteristics: **Fast**
Deposits: ☒ None ☐ Mud ☐ Sludge ☐ Debris ☐ Grease
Silt Depth: (in.) Deposits Extent:
Infiltration: **None** Pipe Seal Cond: **Sound**

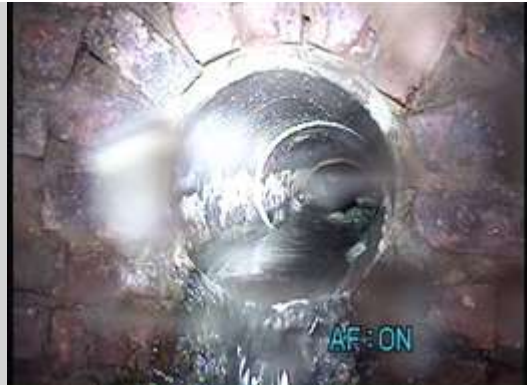
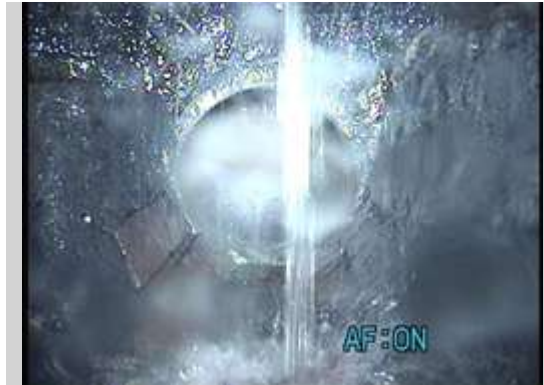
6 O'Clock Inflow

Infiltration: **None** Pipe Seal Cond: **Sound**

Drop Condition: **Open**
